NEW WATERVILLE RESERVOIR DAM

INVENTORY No. NY 195

PHASE I INSPECTION REPORT  
NATIONAL DAM SAFETY PROGRAM

AUGUST 1981

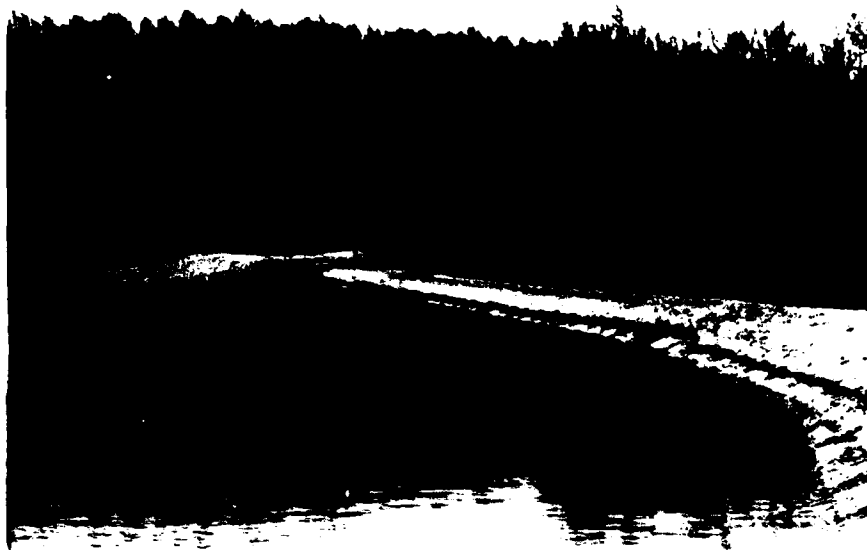
2. Upstream view of embankment looking towards left abutment. Emergency spillway at far end of embankment.

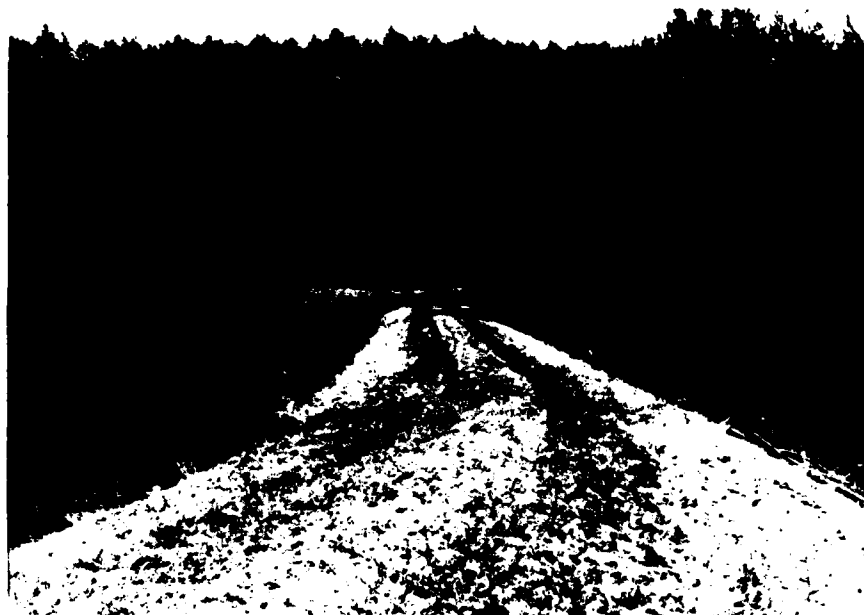
3. Crest of embankment looking towards left abutment.

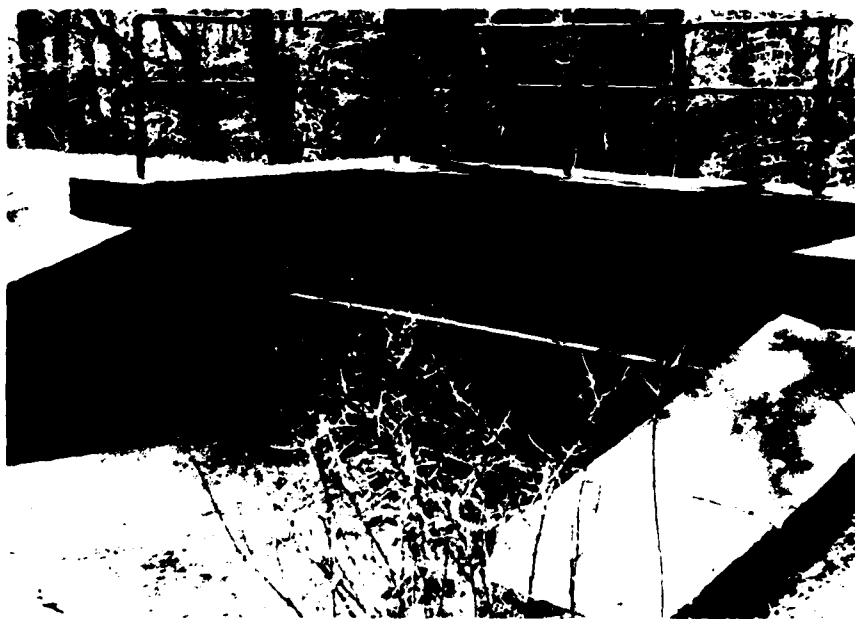
The service spillway situated near the right abutment is in operating condition and only a small amount of debris was lodged on the trash racks.

12. Principal spillway structure as viewed from upstream.
